# Corrosion Technology Services

## Case Study - C939

### Rehabilitation of Concrete Seawater Intake Structure

| <b>Scope of Project:</b> | Rehabilitation of a Reinforced Concrete Sea Water Intake Structure |

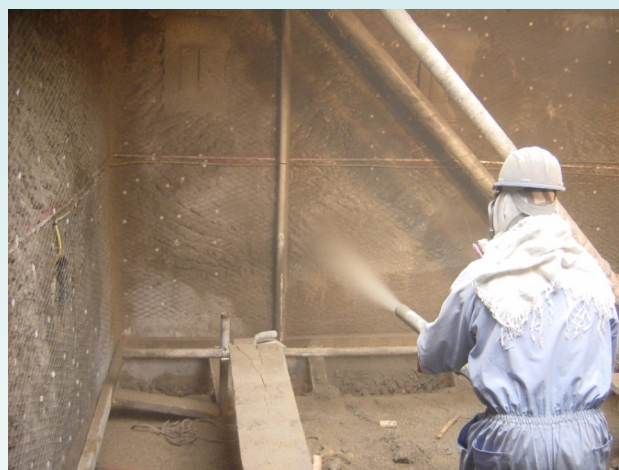
Shotcrete Guniting Over Expanded Mesh

Above water level the structure was divided into tidal and atmospheric zones. MMO coated Titanium ribbon mesh, expanded mesh and discrete anodes system were installed.

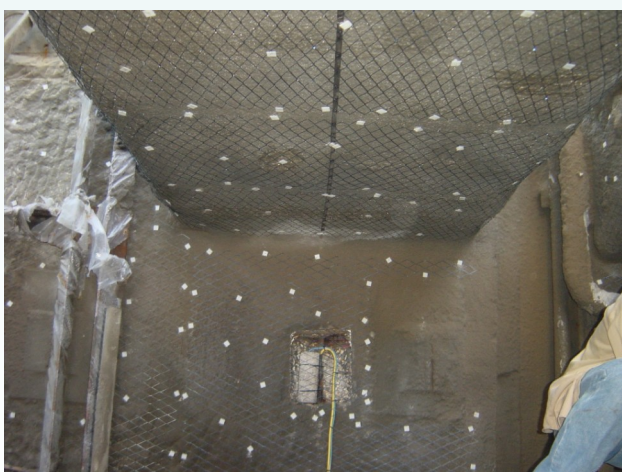
Reference Electrode Installation in Expanded Mesh Wall

The system is monitored using Ag/AgCl reference electrodes (RE's) which are embedded in the concrete. RE's were distributed in order to give a comprehensive analysis of the CP system. There is a minimum of 4 RE's installed per zone and 1 installed per sub zone .

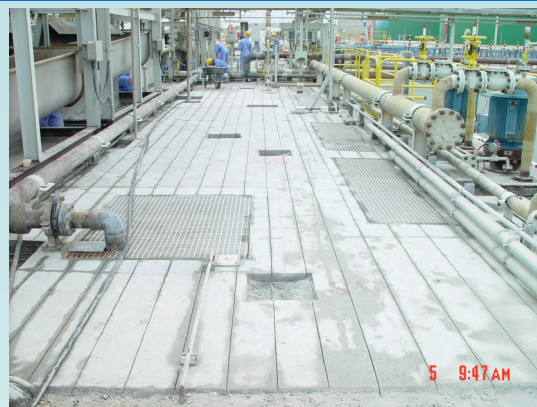
Slotted Anode Installation in Slab

Ribbon mesh anodes were installed in slots or chases depending on the depth of the concrete cover and filled with proprietary grout. In some cases the anodes were installed directly onto the scabbled concrete surface and overlaid with shotcrete.

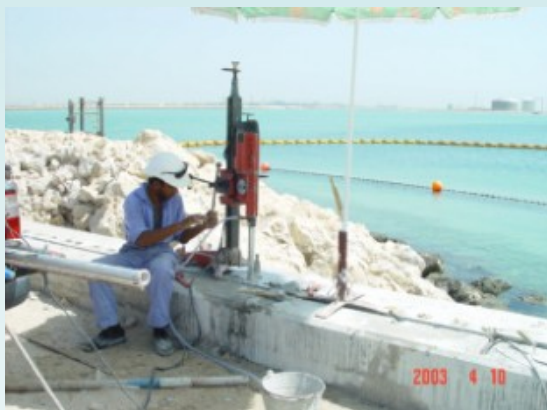
Holes Being Cored in Sea Wall

The sea wall area of the structure was inaccessible to slotted or mesh anode systems. In these locations discrete anodes were installed vertically between the reinforcing steel. Holes were drilled up to a depth of 2m and connected using Titanium conductor bar. Free flow grout was used to encapsulate the anodes. Before installation, testing was carried out to ensure that effective encapsulation was possible.

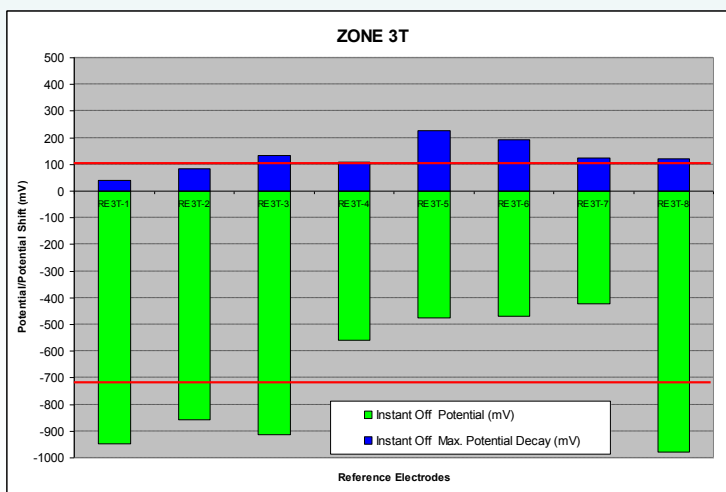
Typical results are displayed in the graph opposite. The graph shows that all locations pass at least one of the criteria and two locations pass both.

Typical Commissioning Graph (Tidal Zone)

- Minimum decay of 100mV from instant off
- Instant off potential more negative than  $-720\text{mV}$  with respect to Ag/AgCl.
